## Land Use Application #1368720 - Nelson Short Plat

## TREE INVENTORY/ARBORIST REPORT

8514 Bowdoin Way  
Edmonds, WA

**February 1, 2024**

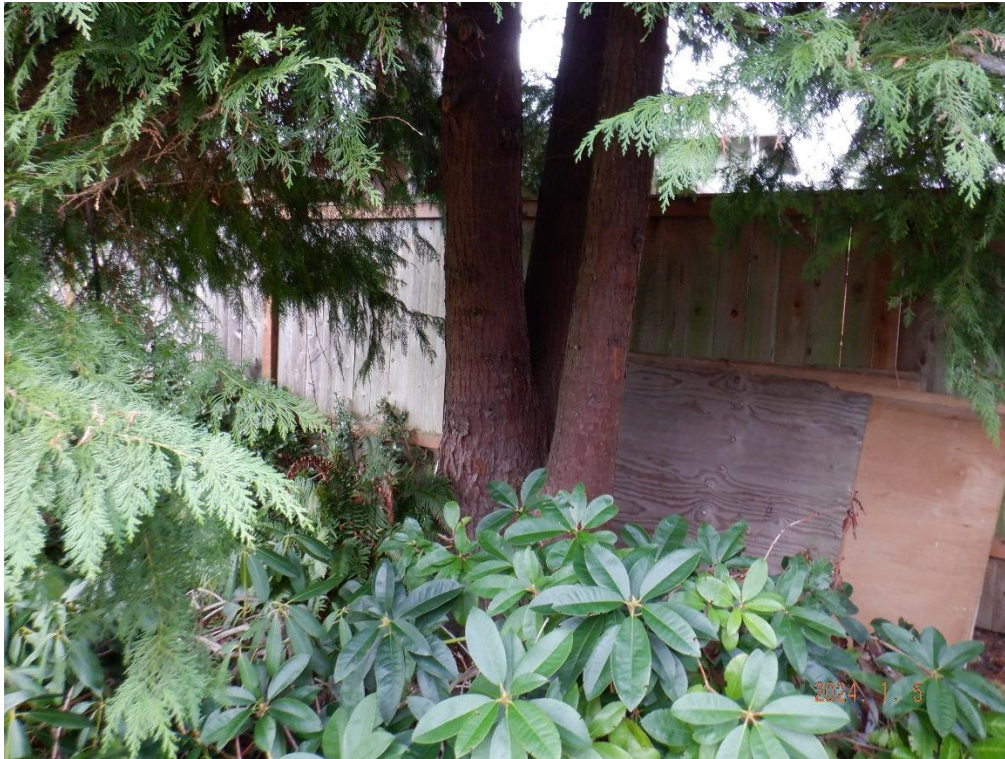
Tree #1 is a semi-mature to mature Lawson cypress. It is comprised of three stems or trunks, which fork at ground level or the root crowns. There is a moderate buildup or accumulation of included or embedded bark between the forked trunks/stems. Vigor is good, foliage is of normal color and density. Condition is 'good'.

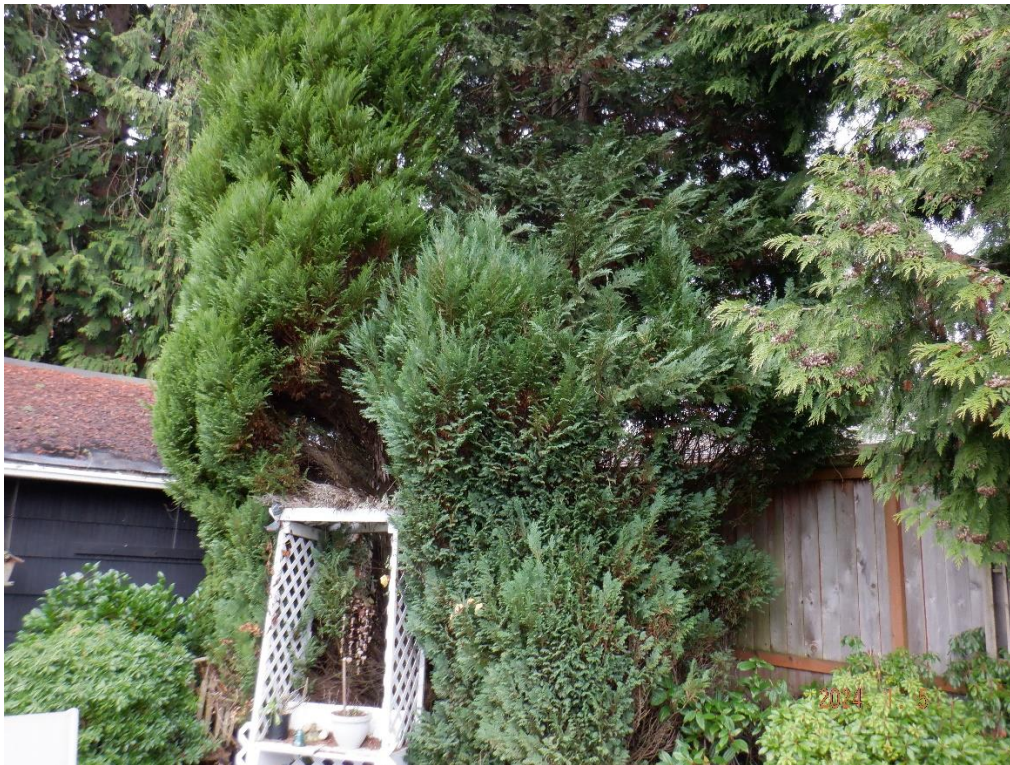
Trees #2 and #3 near corner of garage

Trees #2 and #3 are young to semi-mature cultivated varieties of Lawson cypress. Both are of good vigor. These are both clusters of small stems. Tree #2 has a significant lean. Some smaller stems have recently fallen over. Condition is 'fair'. Tree #3 has developed better structural form. Condition is 'good'.

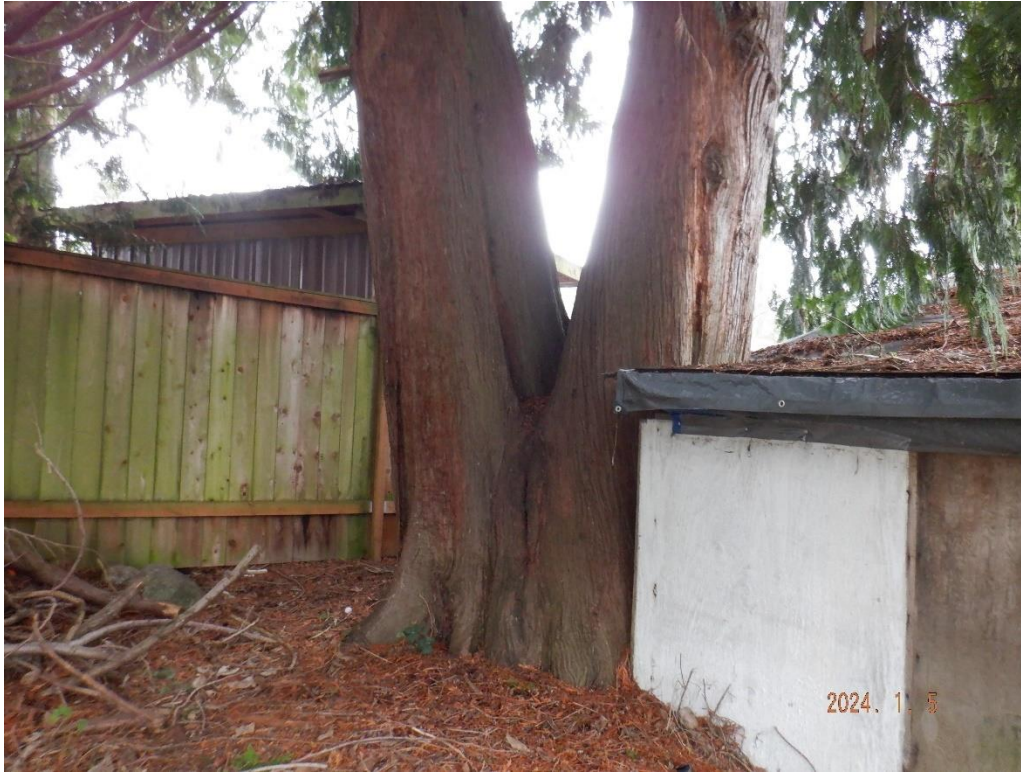
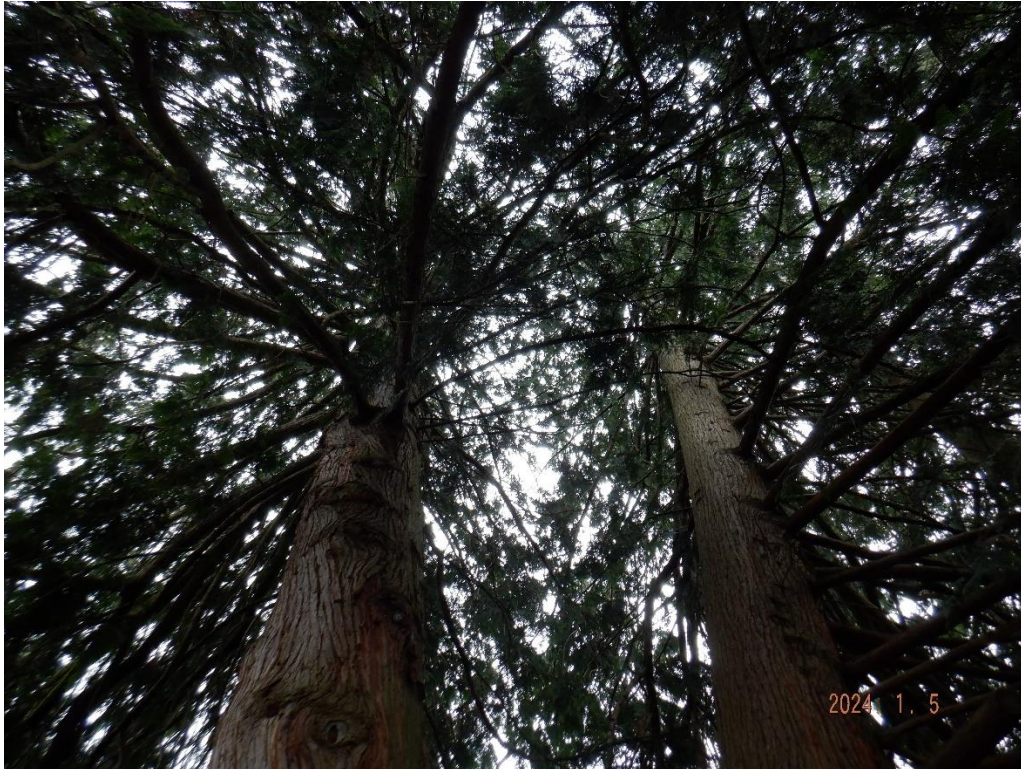
Tree #5 is a mature Western red cedar. It is comprised of two large codominant (equal diameter) trunks. There is a significant buildup or accumulation of included or embedded bark and associated seam between the forked trunks. Stems have developed natural leans away from each other. Vigor is good. Overall condition is rated as 'fair'.

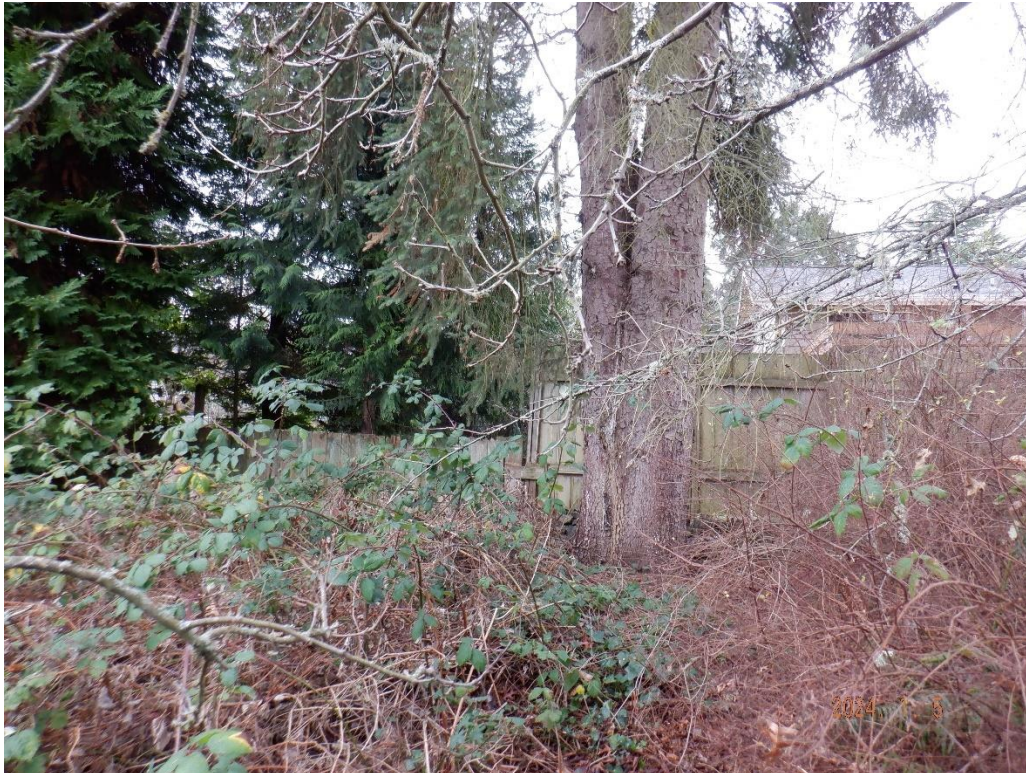
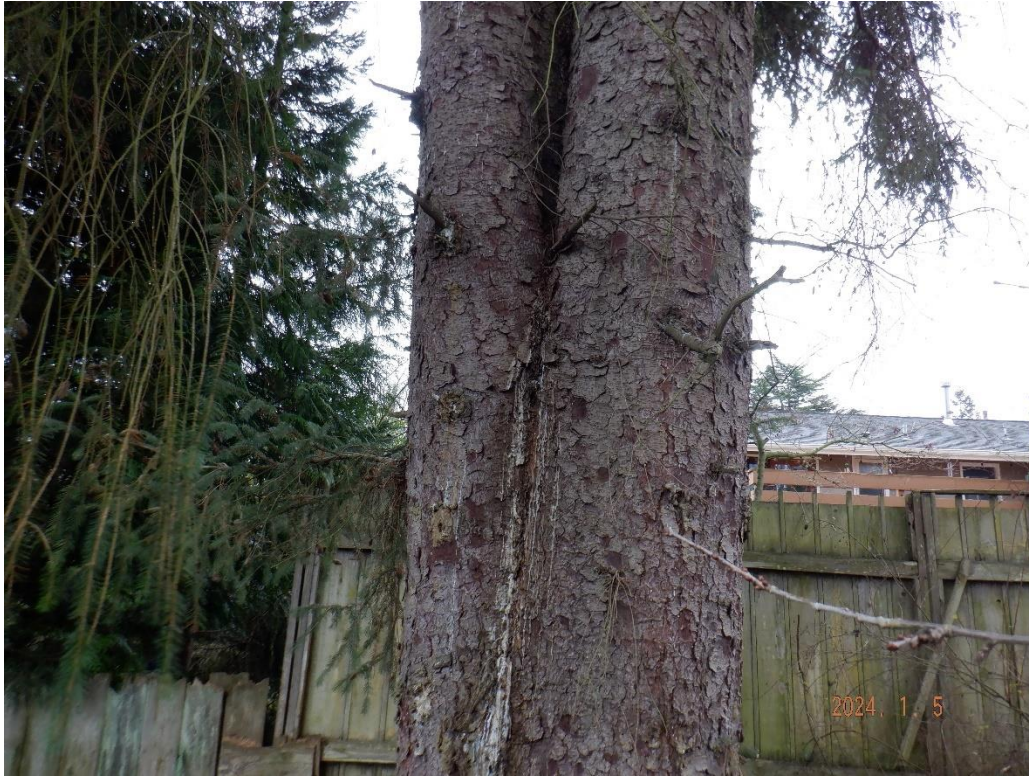
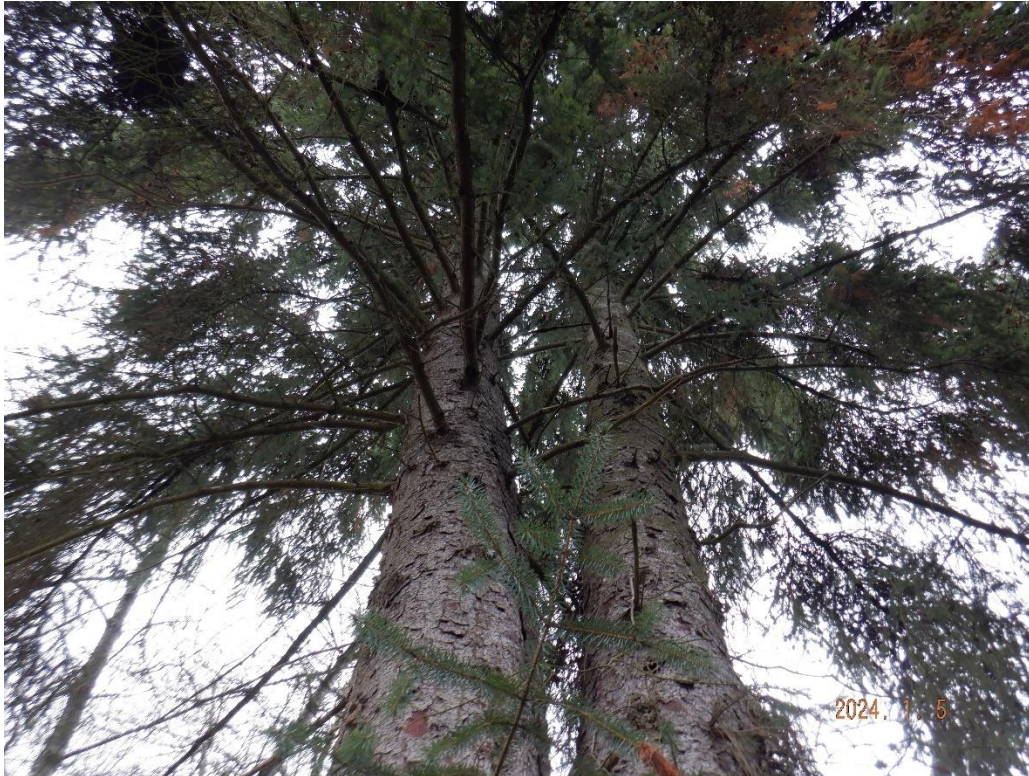
Tree #6 is a semi-mature Sitka spruce. The lower trunk forks at roughly 8-feet above ground into codominant stems or trunks. There is no noteworthy buildup of included or embedded bark between the forked trunks. Stems are upright or vertical with no leans. Vigor is good. Condition is 'good'.

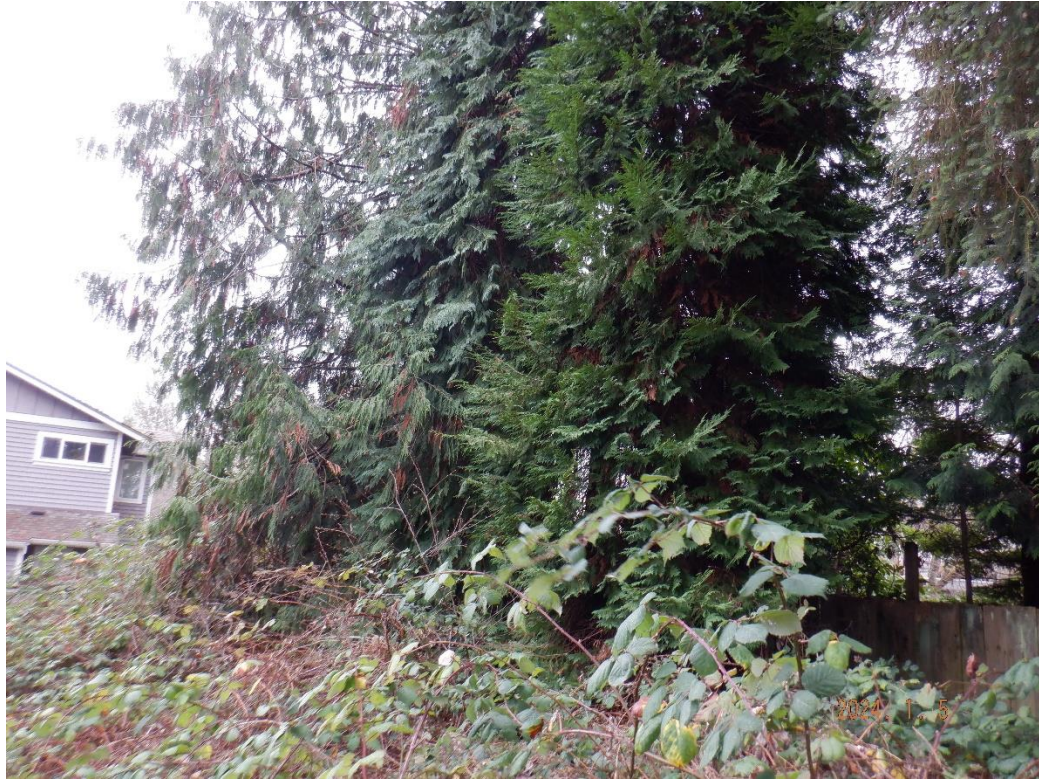
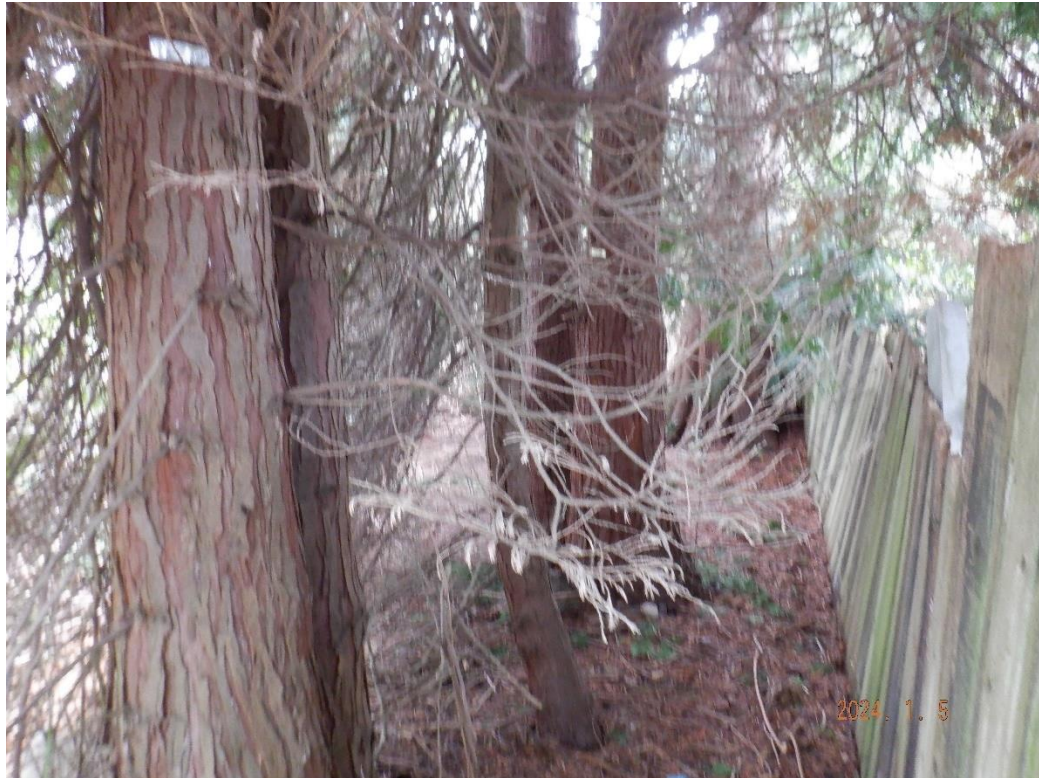
Trees #7, #8 and #9

Trees #7 and #8 are semi-mature Lawson cypress. They have developed typical form for the species and are of good vigor. No concerning issues were observed. Condition is 'good'.

Tree #9 is a semi-mature Western red cedar. It is also comprised of two stems or trunks. One of the forked stems is subdominant. There is no noteworthy buildup of included or embedded bark between the forked trunks. Stems are upright or vertical with no lean. Vigor is fairly good. Condition is 'good'.

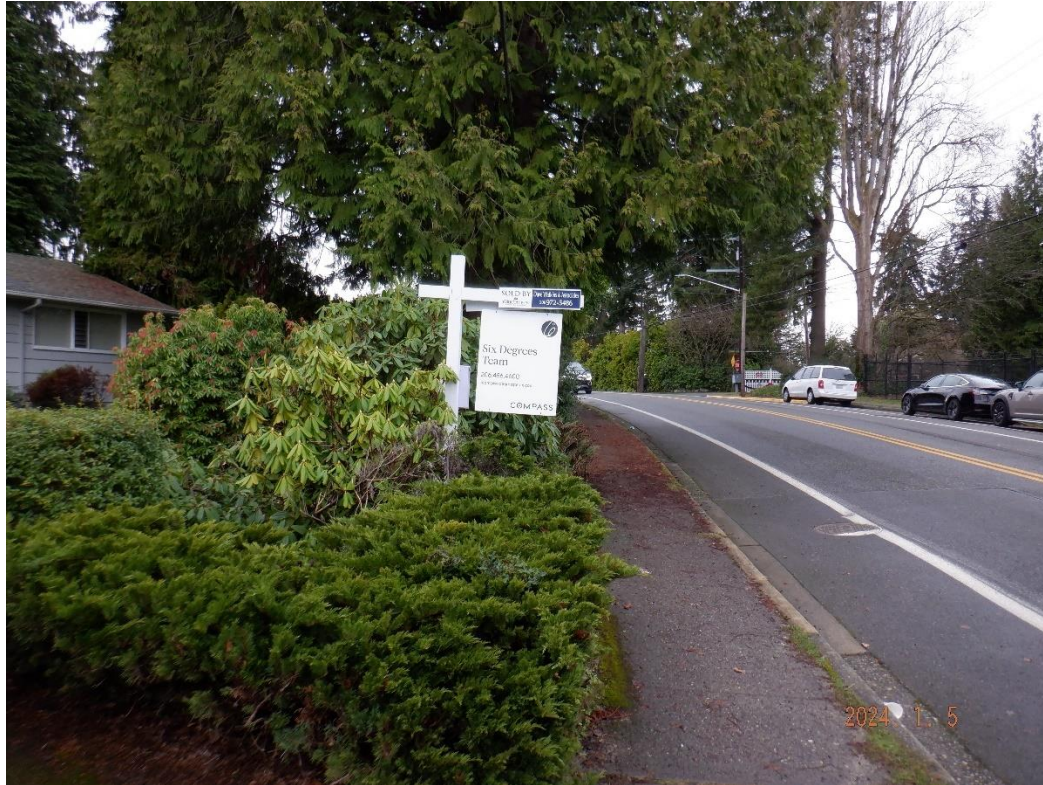
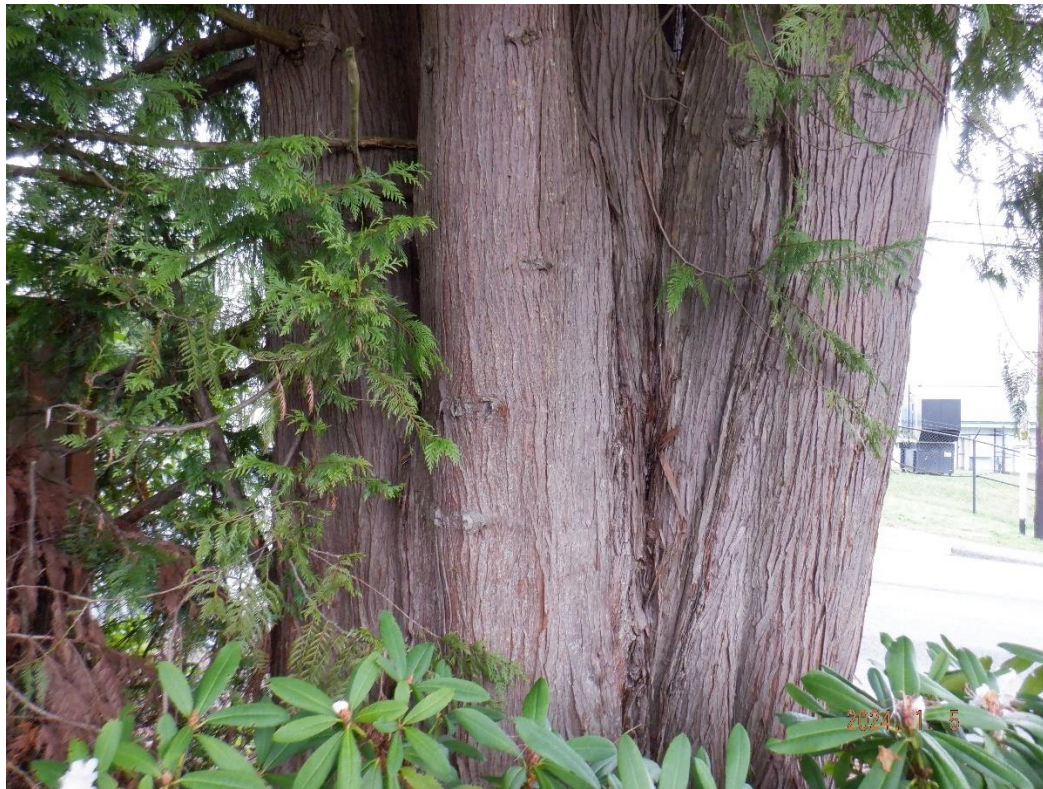
Tree #101 is a semi-mature Western red cedar. This is a large cluster comprised of seven stems or trunks. There is a moderate buildup or accumulation of included or embedded bark and associated seams between some of the forked trunk attachments. Vigor is good. Overall condition is rated as 'good'.

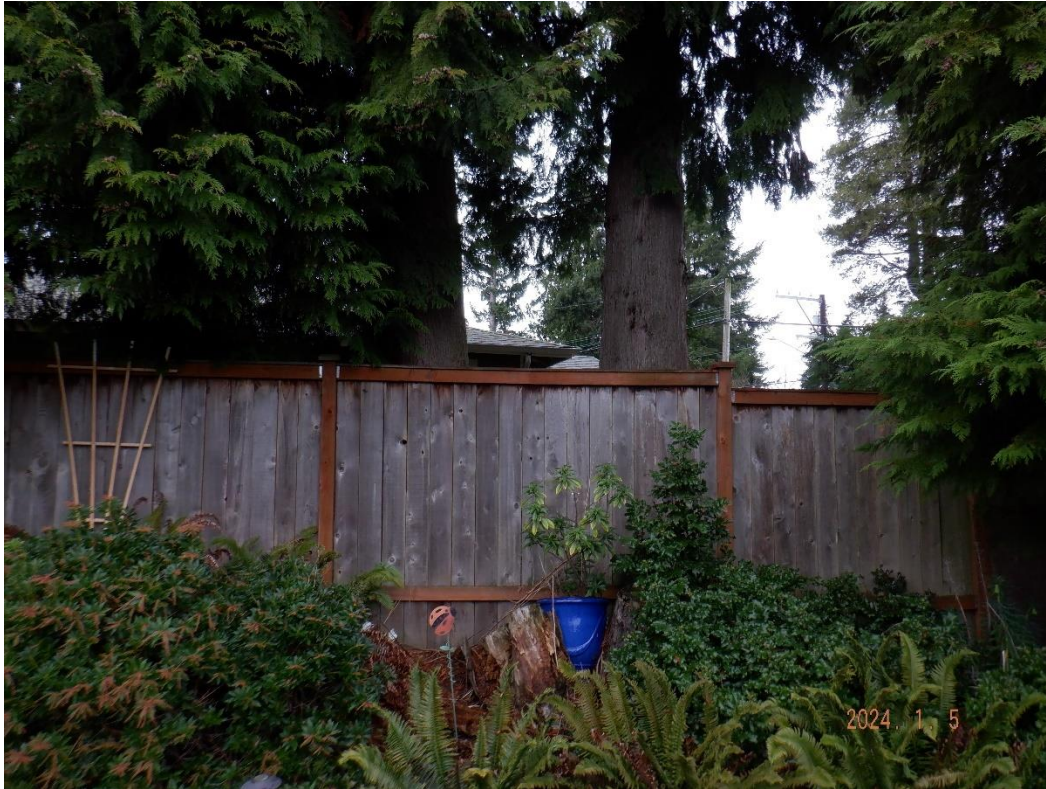
Trees #103 and #104 are semi-mature Western red cedar. No concerning issues were observed from the subject property side. Condition is 'good'.

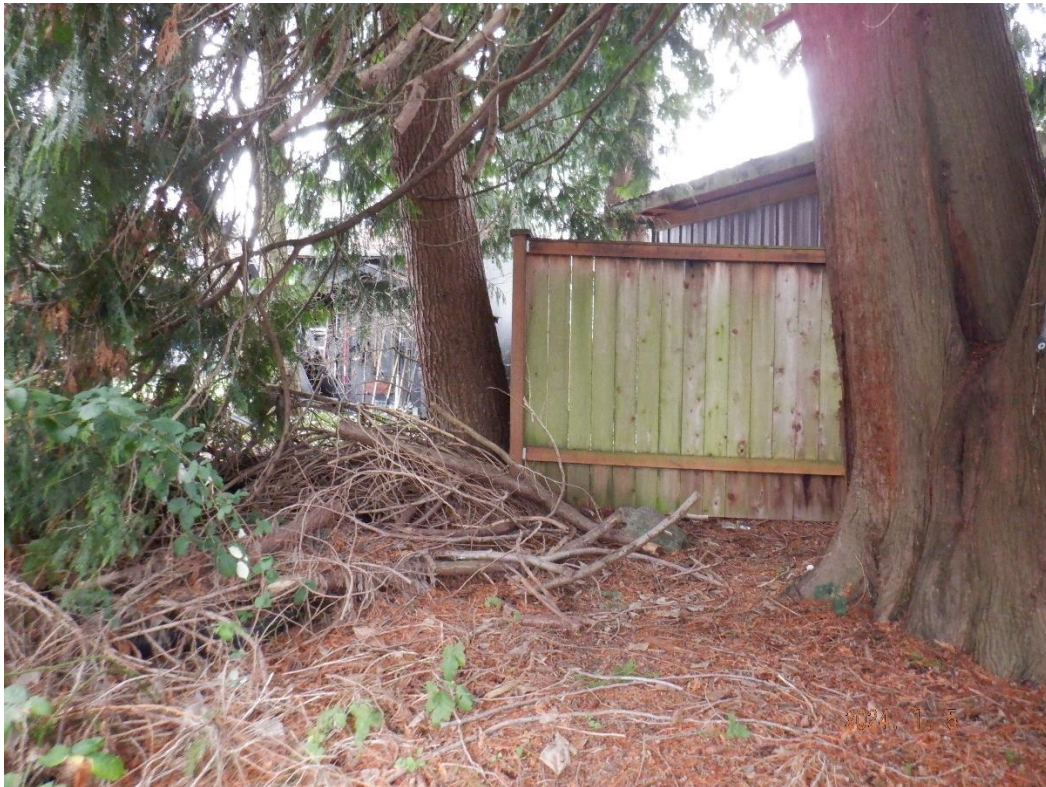
Tree #105, at end of fence

Tree #105 is a young to semi-mature Douglas fir, located close to the west property line. Vigor is good. No concerning issues were observed from the subject property side. Condition is 'good'.

The most noteworthy impacts will be to neighboring Tree #105. The cut for the new foundation will be roughly 5-feet from the property line, inside its dripline and normal limits of disturbance. Severing roots at the foundation cut east of the tree would not be expected to have any adverse impacts on its structural stability. This is a young to semi-mature specimen. This is a hardy species and tolerable of noteworthy impacts. It is expected to remain viable post construction. The project arborist should be on-site to oversee the foundation excavation so any impacted roots can be properly pruned and to minimize overall impacts. The cut stump of Tree #5 shall be grinded down to just below grade to minimize impacts to Tree #105

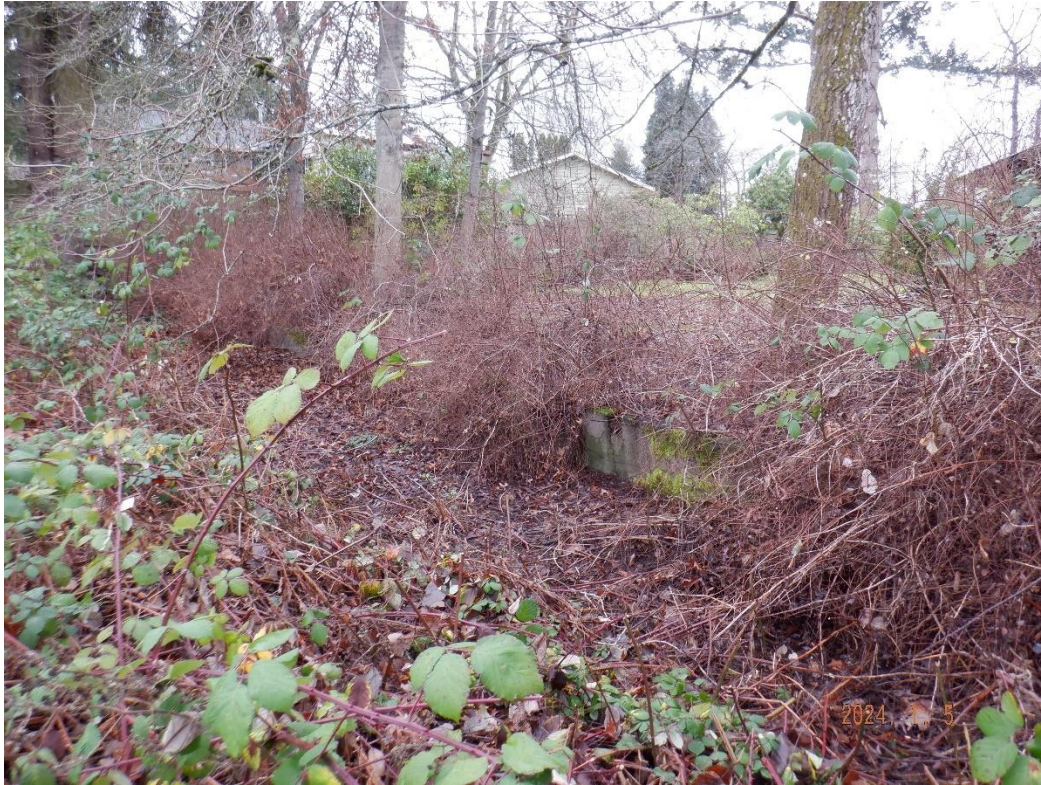
Trees #106, #107 and #108

Tree #106 appears to be a semi-mature English walnut. No concerning issues were observed from the subject property side. Condition is 'good'.

Tree #107 is a young to semi-mature red oak variety. No concerning issues were observed from the subject property side. Condition is 'good'.

Tree #108 is a semi-mature native bitter cherry. It has developed poor structural form. The lower trunk forks into codominant stems. The forked attachment appears weak. Condition is 'fair'.
